Technical Memorandum

To: Chris Byrd
Benton County
From: Garrett Monson, PE
Houston Engineering, Inc.
Subject: Benton County Ditch 3 Repair
Date: April 1, 2021
Project: 6183-0004

BENTON COUNTY
REPAIR REPORT
FOR
BENTON COUNTY DITCH NO. 3
BENTON COUNTY
NOVEMBER 2020

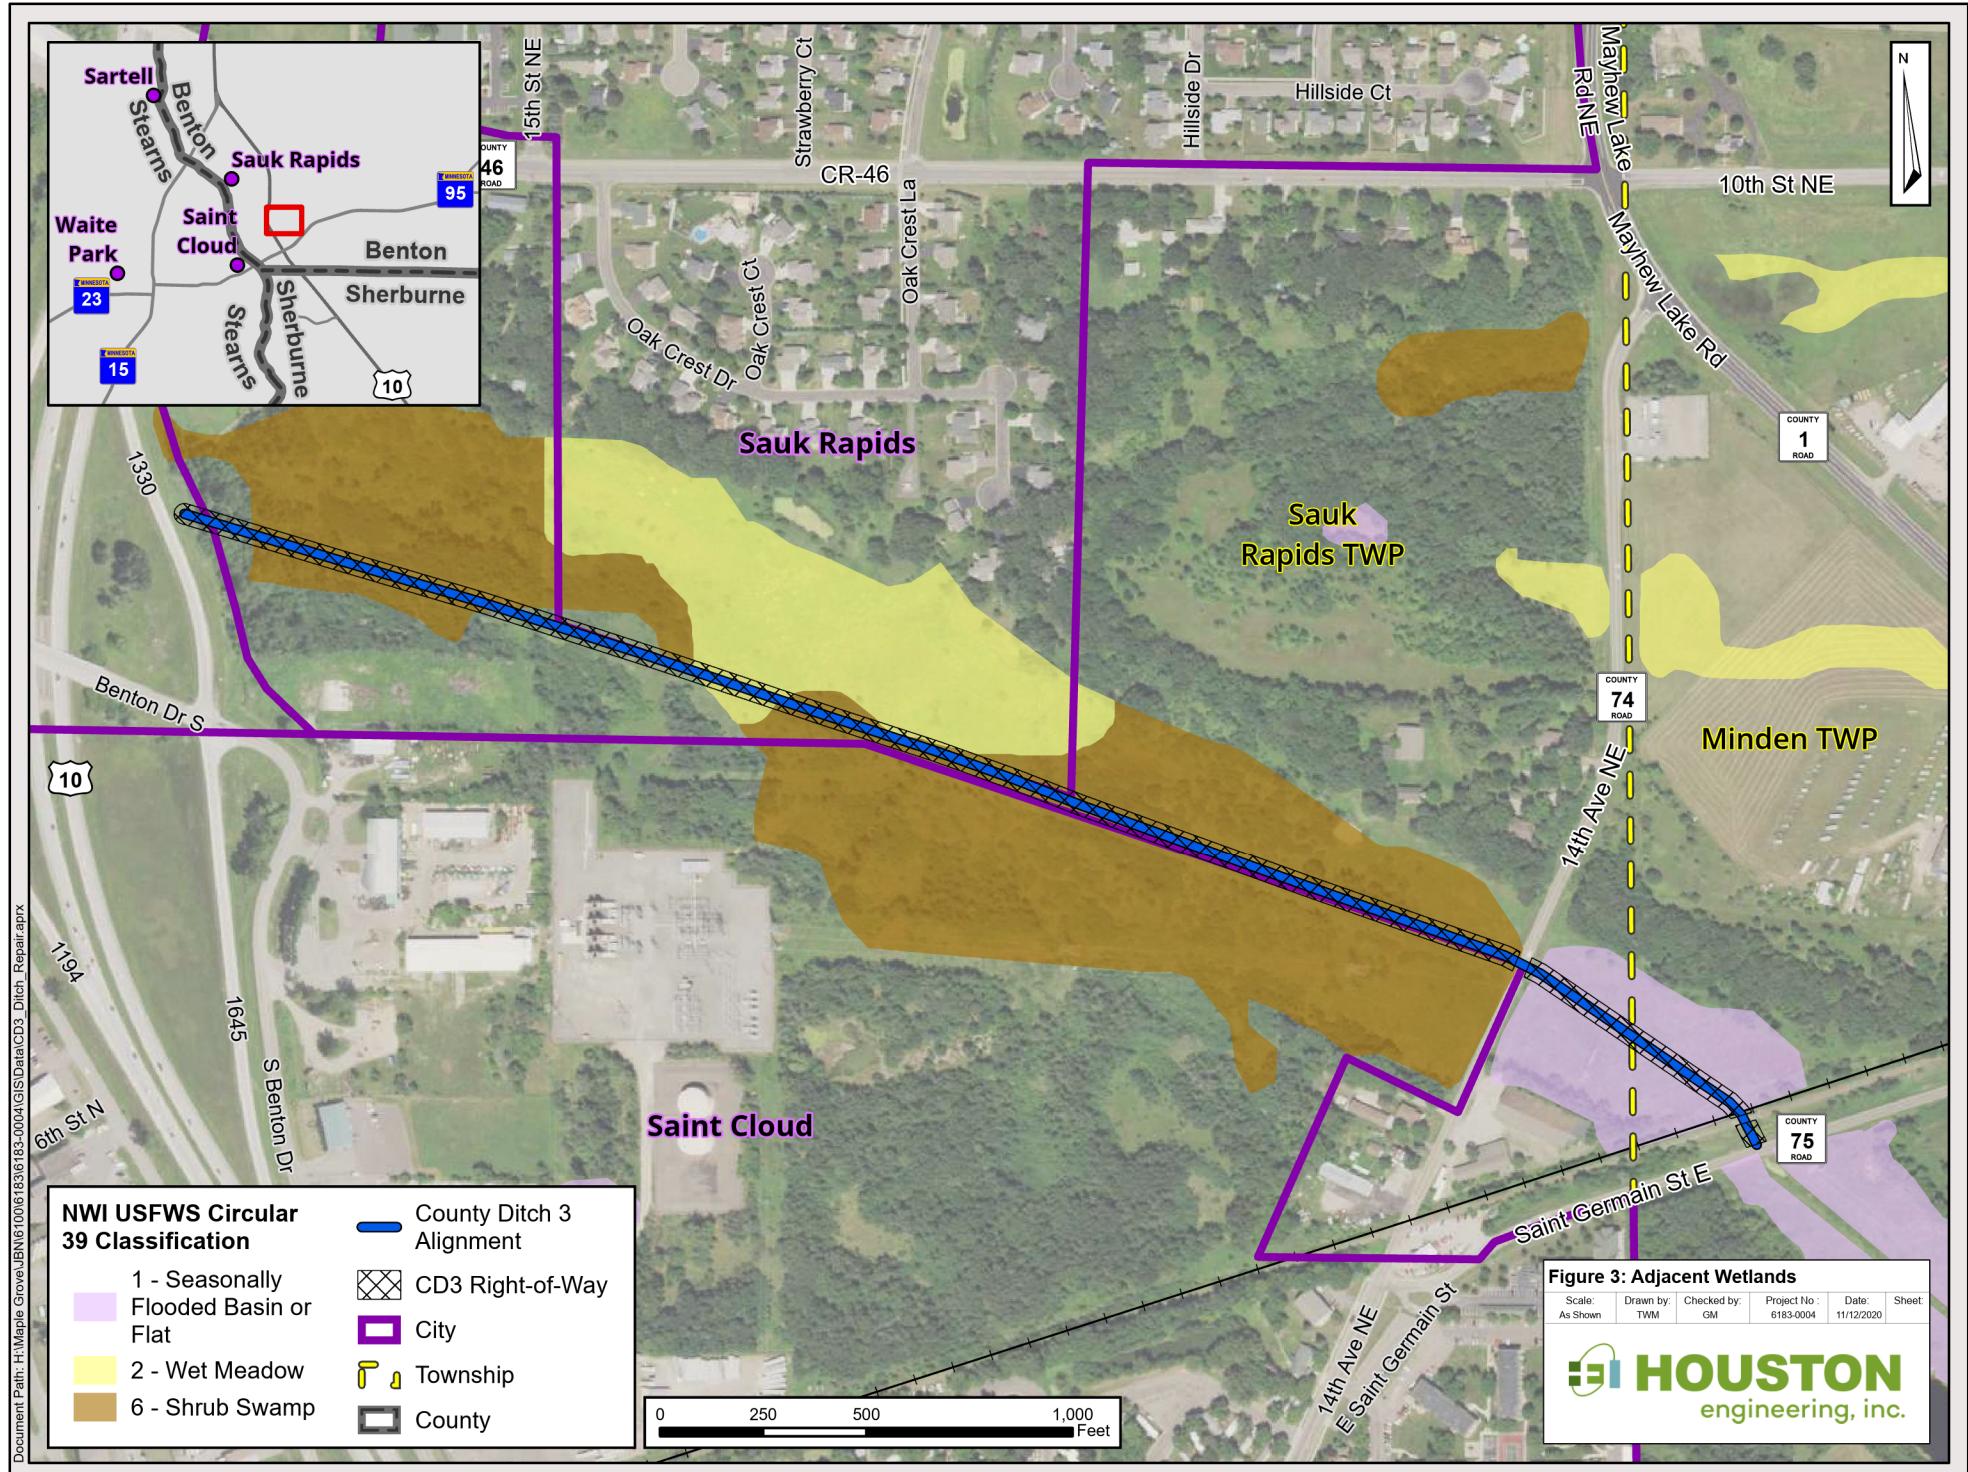
The CD 3 public drainage system intersects wetlands identified in the MnDNR National Wetland Inventory (NWI) as shown in **Figure 3**. Under the two wetland regulatory programs, (Minnesota WCA and Federal CWA) activities related to repair of a public drainage system are generally exempt from permitting and mitigation requirements. These activities related to public drainage system maintenance and repair, and include:

Based on a review of the NWI data and aerial photography to confirm wetland types, the wetlands identified within proximity to CD 3 are Type 1, 2, and 6 wetlands (**Figure 3**). There do not appear to be any Type 3, 4, or 5 wetlands within the CD 3 area, therefore the drainage system repair project will meet the exemption criteria of the state WCA and no wetland permitting is required.

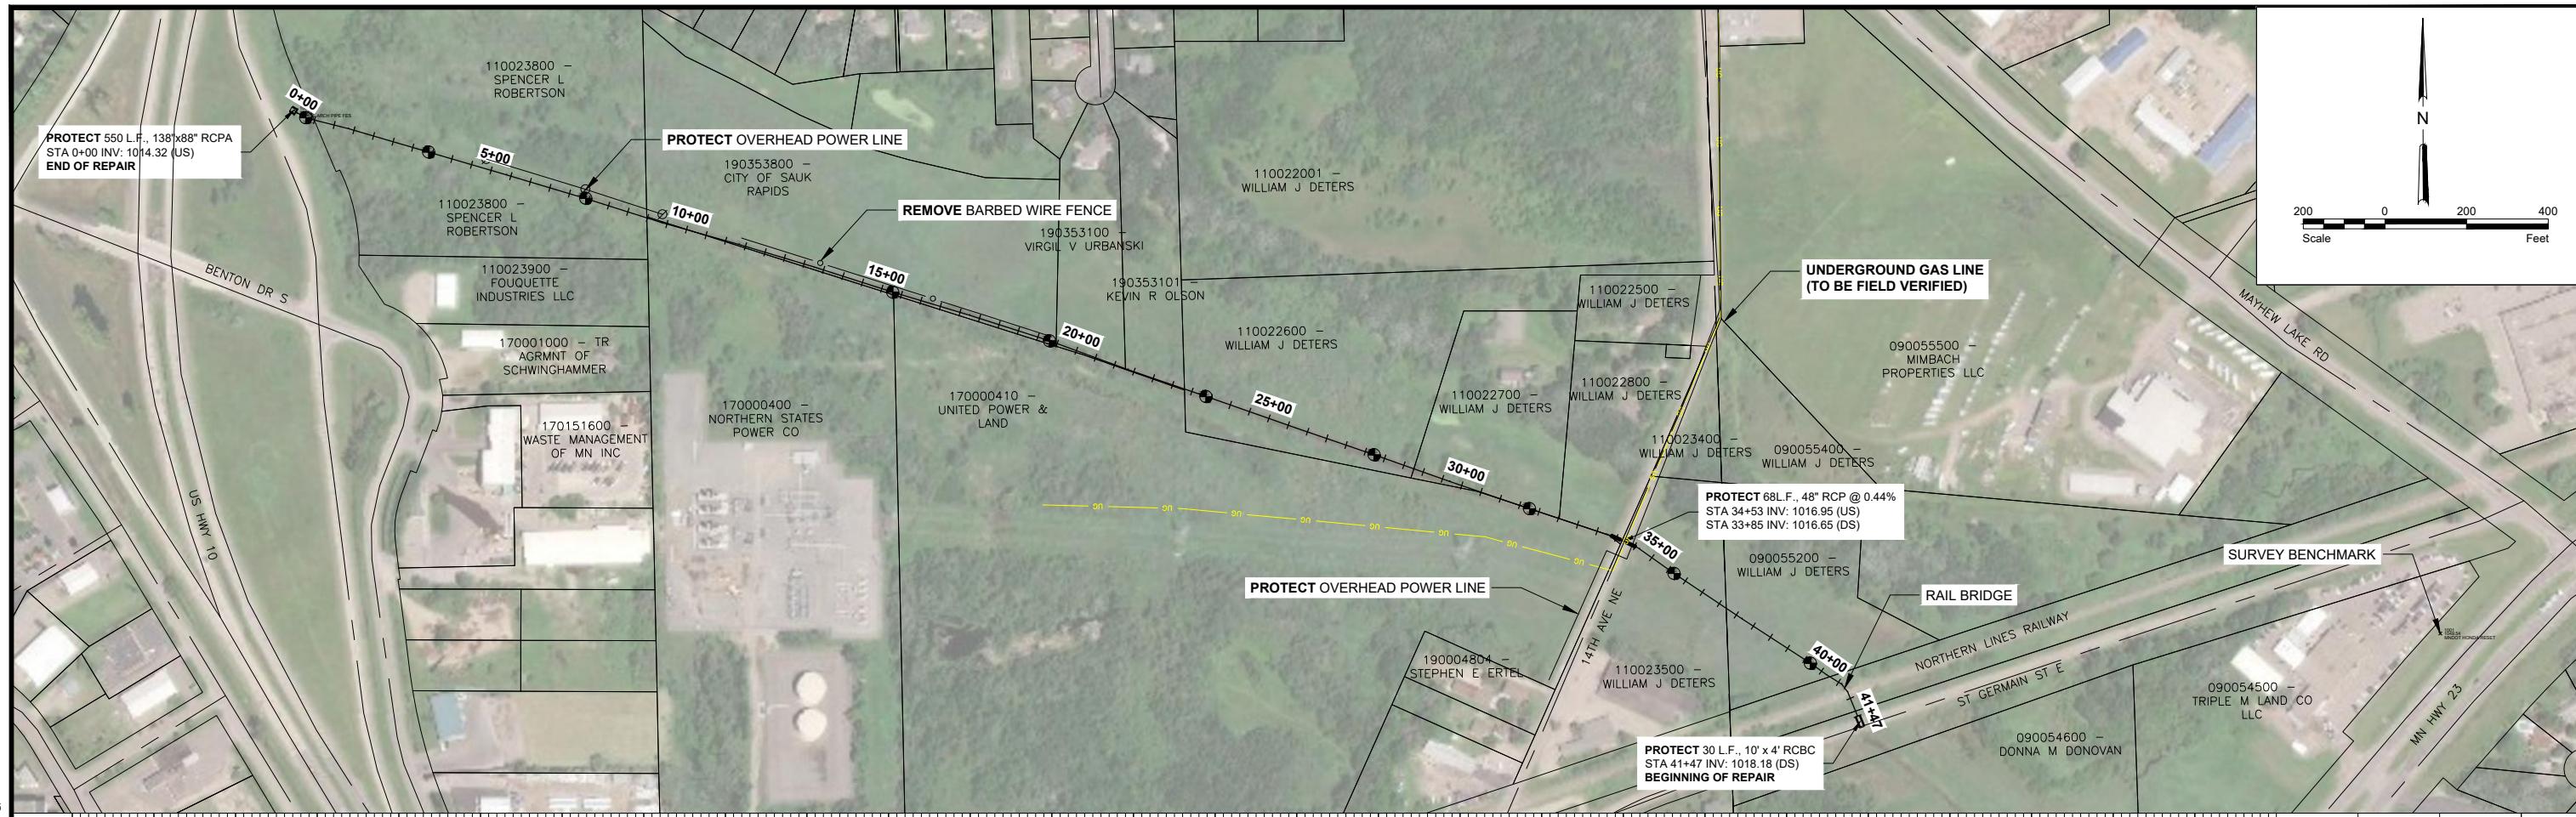
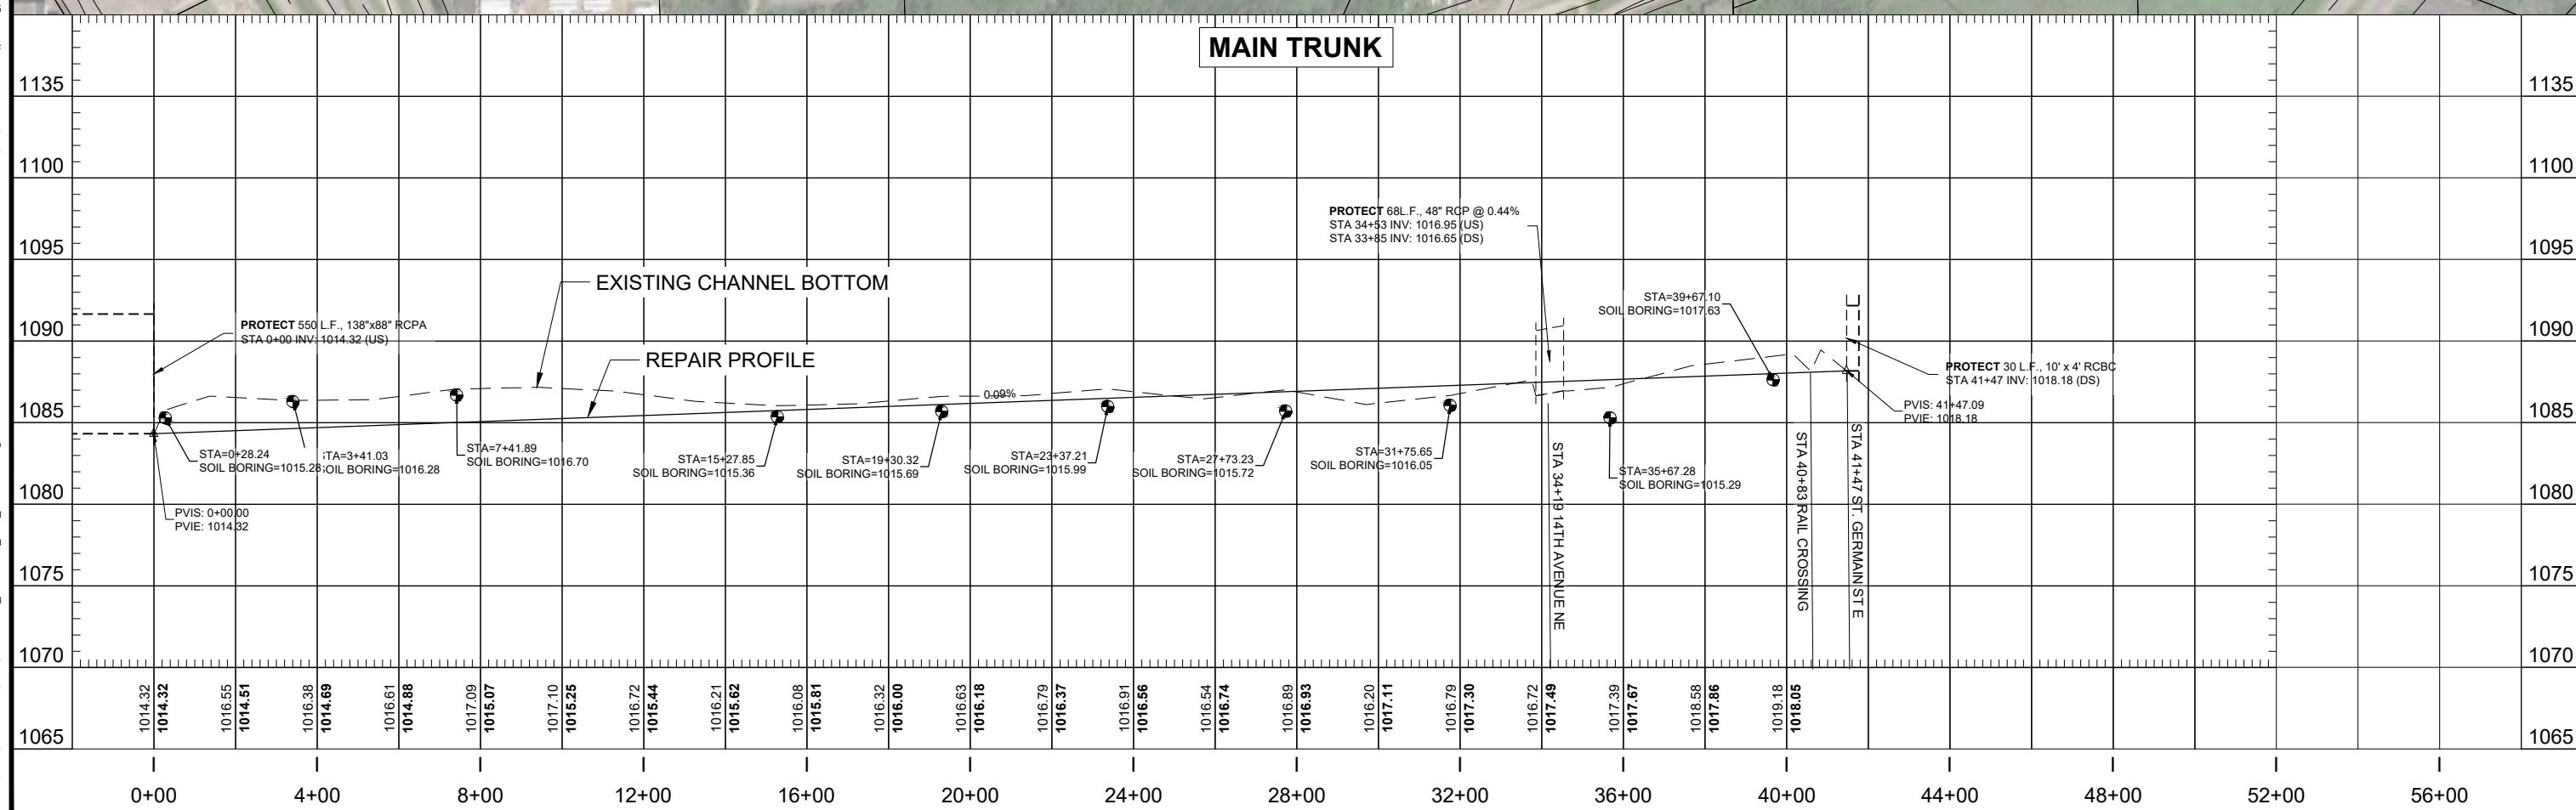
PLAN AND PROFILE

The CD 3 system was discovered to have accumulated sediments ranging from 0.1 to 1.9 feet thick based on the HEI survey performed in October of 2020. To restore the function of CD 3 to the ACSIC requires that the accumulated sediment within CD 3 be removed.

The purpose of the proposed repair is to restore the drainage system function to a level of service consistent with the as-constructed and subsequently improved condition of CD 3 within the project area. For the open channel portion of CD 3, this can be done using the repair profile shown in **Attachment A**.
